November 28, 2017

Thank you for taking time to visit and survey parking at Fellsmere Park and Pond today. The following notes and images provide a recap of our discussion.

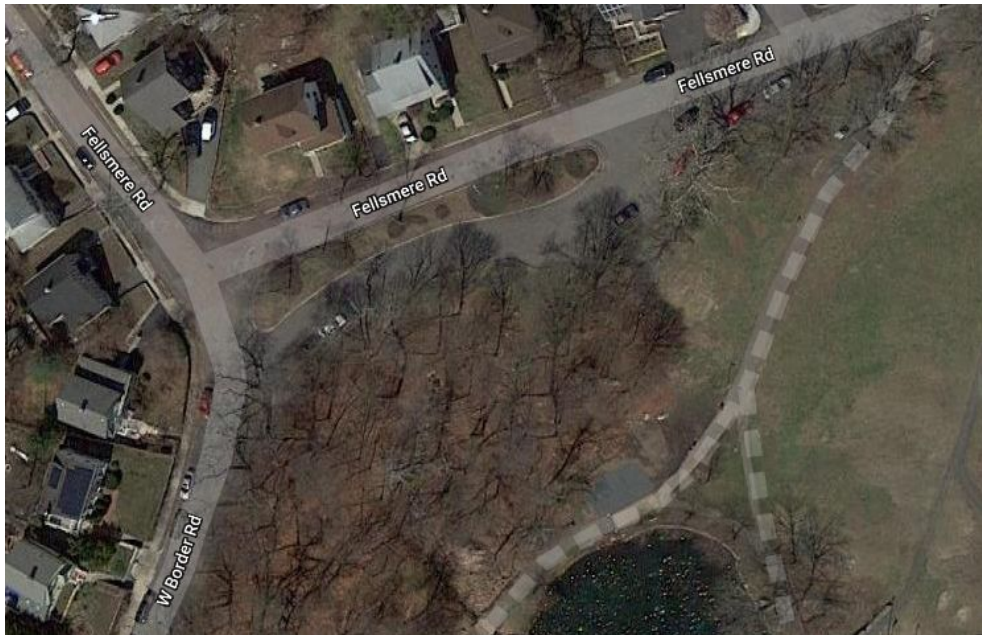
At present, there is no handicapped parking anywhere along the immediate border of Fellsmere Park or Pond. The following aerial image shows the area under consideration, which we believe to provide the most convenient and safest access to the park for a vehicle with handicapped tags:

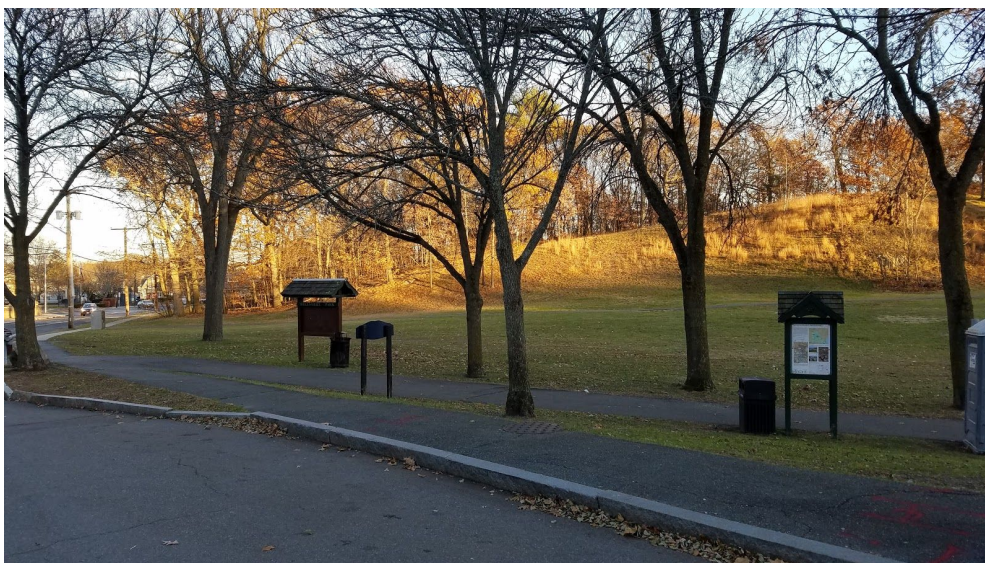
We agreed this area was conveniently placed for a handicapped parking spot. It appears the low, sloping piece of curbstone in the following photo might be removed, with a ADA compliant ramp added. Our discussion involved painting handicapped markings on the pavement.

We focused on this area as relatively safe and protected. We also concurred that the Handicapped parking space should be long and large enough for a wheelchair van or other comparable vehicle which might be used to transport multiple handicapped individuals to the park. Requirements for van-accessible parking spaces is at [https://www.ada.gov/restriping\\_parking/restriping2015.html](https://www.ada.gov/restriping_parking/restriping2015.html).

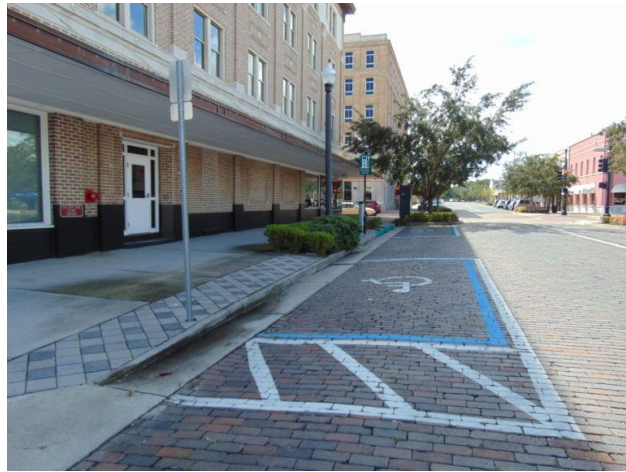
We discussed the idea for parking parallel to the existing curb, as if a space were being added to the front of a residence on a city street. However, parallel parking (versus head-on parking) poses a number of accessibility issues which may push us to rethink the location or may require additional sidewalk work to achieve the desired layout. The following photo shows one example of semi-accessible parallel parking:

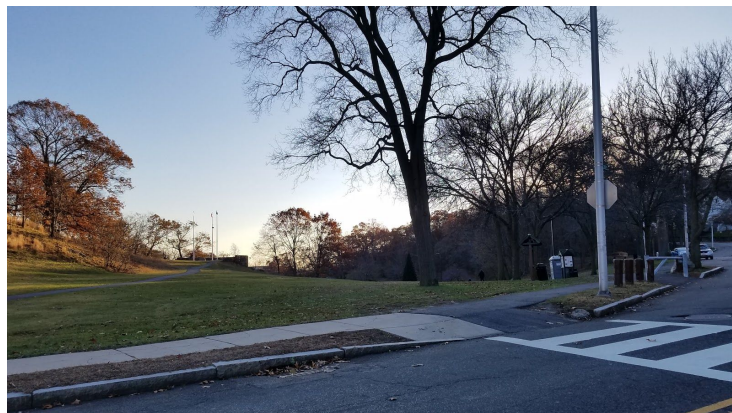
An existing crosswalk, with curb cut and sidewalk access is a short distance away, allowing existing access routes if the curb cut above were deemed impractical or prohibitively expensive.

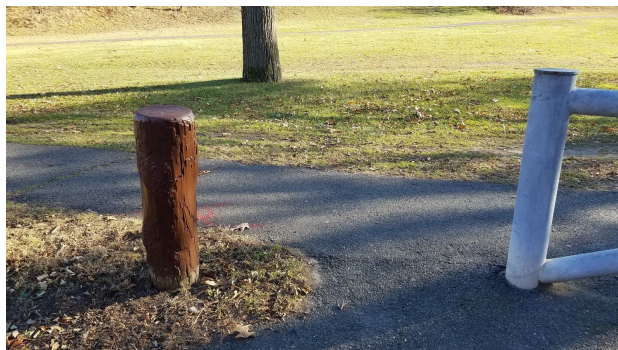
We also observed this metal gate and wooden post nearby the proposed handicapped parking spot. Our sense was the spacing of these posts allows for safe passage between them for a pedestrian with a walker, along with an aide, or a wheelchair.

It would be desirable to remove the grassy dirt around the wooden pole and smooth that surface. It appears minimal effort and cost would be required to transform this location into a nicely graded access point with gradual slope which would be friendly to wheelchairs and walkers.
